Small House; Construction Cost \$100K, Total Energy Cost \$0.88 a Day

Abstract

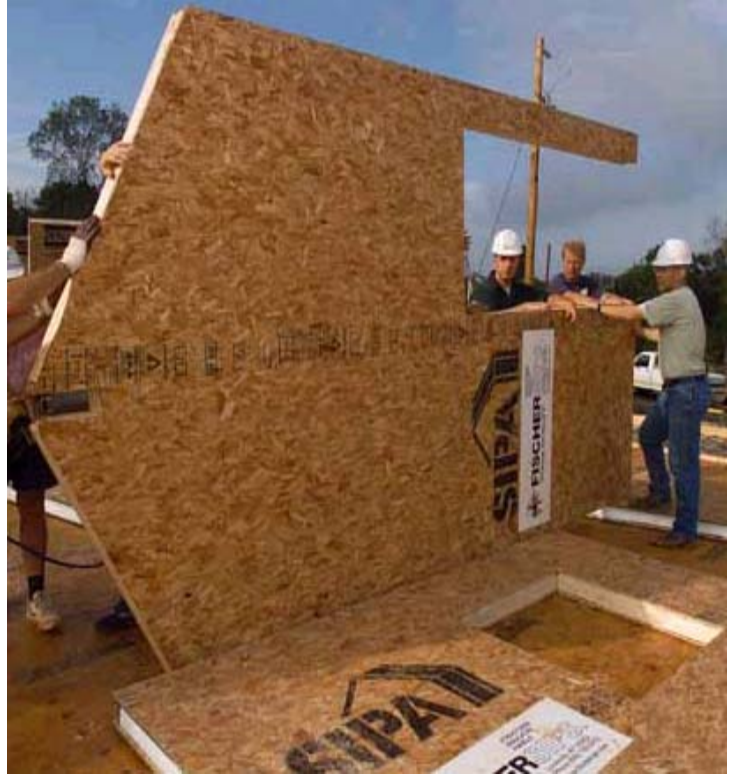
Figure 4 picture of the SIPS being installed in ZEH2

The house cross section and floor plan are shown in Figure 2 and Figure 3. The main duct trunk line is located above the drop ceiling under the ridge beam. The house walls are 4.5 inch thick SIPS with 1.8 lb/ft³ expanded polystyrene (EPS) sandwiched between two layers of 7/16 inch Oriented Strand Board (OSB). We used ASTM C518 procedure in the heat flow apparatus that yielded an R-value of 16.1hft² °F/Btu for the 4.5 inch SIP (1.8 lb/ft³ EPS). These panels were prefabricated off site with rough openings for windows and doors. The wall panels are 8 ft high and various lengths on the eave walls sized to fit the 6/12 gable on the front and back of the house. The 21 wall panels widths varied from 1 ft to 12 ft. Besides the eight corner joints another 13 wall joints were needed to enclose this house. Figure 4 shows ZEH2 during the SIP walls installation. The panels were fastened together using structural splines. Each panel-to-panel connection was caulked at all spline-to-foam contact surfaces. The 8 windows, one less than in ZEH1, in the house are wood vinyl clad doublehangs with the same National Fenestration Rating Council (NFRC) labeled U-factor of 0.34 Btu/ft²°F and Solar Heat Gain Coefficient of 0.33 as used in ZEH1, ZEH3 and ZEH4.
