The Temperature/Pressure Relief Valve

One of the most common code violations our inspectors observe in the field involves the Temperature/Pressure Relief (TPR) Valve on the water heater unit. The purpose of this article is to assist property owners and inspection professionals in identifying these common code violations so they may be prevented and corrected.

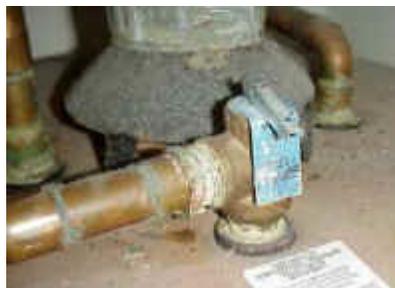
Figure 1 - Typical installation of a Temperature/Pressure Relief (TPR) Valve on a gas water heater

If not allowed to properly discharge, this excess temperature and pressure will eventually cause the tank to explode. One such tragedy occurred in Spencer, Oklahoma at the Starr Elementary School on January 9, 1982 where six children and a teacher were killed when the school's water heater exploded with the force and effect of two pounds of dynamite. This occurred due to a malfunctioning TPR valve. **Figure 1 (right)** shows a typical Temperature/Pressure Relief (TPR) Valve installation on a gas water heater.

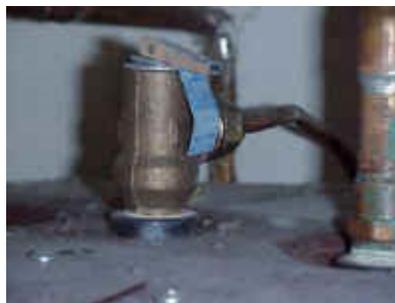
Figure 2 (right) shows a TPR Valve that has been fitted with a discharge pipe that is **smaller** than the size of the valve outlet. This is a common defect that is strictly prohibited because smaller discharge pipes restrict the flow of the pressurized water released by the valve. This creates a dangerous bottleneck, building-up even more pressure at the point of discharge that can cause the tank to explode. Personal injury (or death) and property damage may result.

Figure 2 - Improperly sized TPR discharge pipe

Code Section 3303.6.1.[\(i\)](#) requires that the TPR valve is fitted with a discharge pipe that provides the **same size opening as the valve outlet itself**.

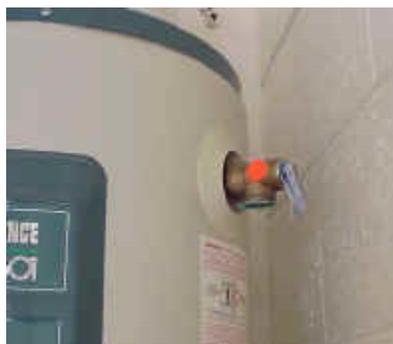
Figure 3 (right), shows a missing TPR discharge pipe. This creates a dangerous condition whereby the TPR valve will spray scalding steam or scalding hot water onto anyone (or anything) that happens to be near the water heater when discharge occurs.

When you consider that the TPR valve discharges water at 210° F., serious injury or property damage will result.

Figure 3 - Missing TPR Valve discharge pipe

In many instances, the discharge pipe required in Section 3303.6.1.[\(i\)](#) was never installed at all. This normally occurs during replacement or initial installation of the water heater.

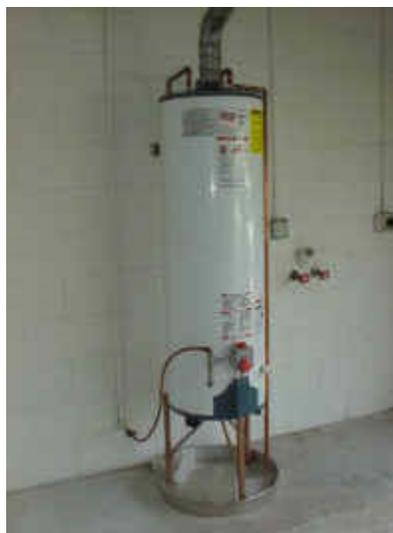
This is clearly not the case in **Figure 4 (right)**. Here we see the copper discharge pipe runs down the right hand side of the water heater tank to terminate into a metal spill pan below. However, the problem lies in the fact that the end of this discharge pipe terminates below the upper rim of a shallow spill pan.

This installation of the discharge pipe poses several potential dangers.

First, the discharge pipe may be able to siphon any liquid that may accumulate inside the pan. This is due to the fact that the end of the discharge pipe terminates below the top rim of the receptacle itself. Once siphoning occurs, the liquid (be it dirty water, household chemicals, oil, etc.) will be drawn back into the water heater tank, thereby contaminating the household drinking water supply.

While this occurrence is admittedly unlikely due to the fact that the TPR valve would have to fail (stay open) while a simultaneous drop in line pressure would create a siphon, the mechanical potential does exist for this contamination to occur. Thus the air gap provision in the building code.

Figure 4 - Improper Termination of Discharge Pipe.

Secondly, and even more likely, is the risk of personal injury when this TPR valve discharges. This is because the discharge pipe terminates into a spill pan that cannot safely catch the flow of water or steam during discharge. When you consider that the TPR valve discharges at 150 psi, which is five times greater than the force of your garden hose, the scalding water can strike the bottom of the shallow pan and spray out in all directions.

Therefore, a deeper spill pan receptacle with adequate circumference would be advisable over the shallower, tightly-fitting spill pans commonly observed in the field.

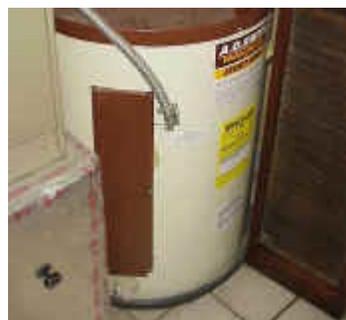
Figure 5 (right), shows a spill pan that tightly fits the base of a water heater. Unfortunately, such an installation accomplishes little in the way of catching water or steam from the TPR safety discharge valve, rendering the spill pan useless.

Spill pan installations depicted in this photograph are common in condominiums and some residential homes where space is a premium.

Figure 5 - Inadequate Water Heater Spill Pan Sizing
