**TB-A028-06 - A. O. SMITH - FVIR INTELLI-VENT TROUBLESHOOTING CHART**

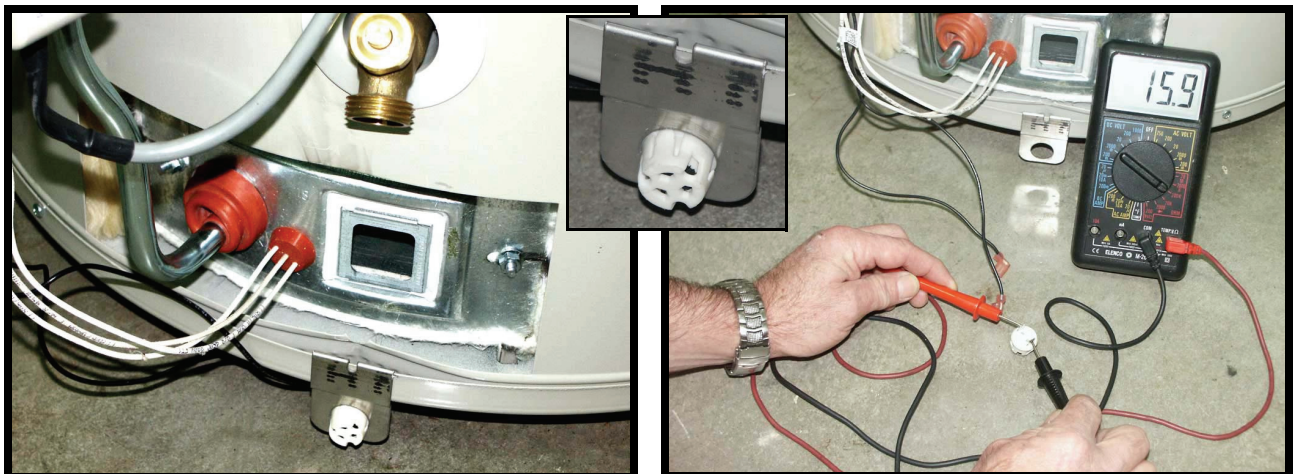
### Flammable Vapor Sensor Location / Testing

<p>The self diagnostic test has detected the flammable vapor sensor is either open or shorted.</p> <p>The Intelli-Vent control is programed to lock-out and display this error code if the resistance value it senses from the FV sensor is below 5,000 ohms or above 1,700,000 ohms.</p> <p><b>Service Note:</b> To perform this test the ohm meter used must be capable of reading up to 2,000,000 ohms.</p>	<ol style="list-style-type: none"> <li>1 Turn off power to the water heater. Ensure all FV sensor wiring, the ignitor assembly plug, and the ignitor assembly socket on the bottom of the Intelli-Vent™ control are making good contact. Repair or replace any worn/damaged components that are not making a good connection.</li> <li>2 Restore power to the water heater - if the error code has cleared place the water heater back in operation and allow it to cycle several times to ensure the problem has been resolved. If the error code persists - continue to step 3 below.</li> <li>3 Turn off power to the water heater. Remove the FV sensor from it's bracket on the base ring of the water heater and disconnect both wires to the sensor. Take a resistance reading between the two wiring terminals of the FV sensor and note the resistance value.</li> </ol> <p><b>Service Note:</b> Unless the ohm meter used has an auto-range feature the resistance should be checked twice. The first reading will be taken using an ohms scale above 1,700,000 ohms. The second reading is taken using an ohms scale just above 5,000 ohms.</p> <ol style="list-style-type: none"> <li>4 If resistance of the FV sensor is lower than 5,000 ohms - replace the FV sensor.</li> <li>5 If resistance of the FV sensor is above 1,700,000 ohms - replace the FV sensor.</li> <li>6 If the resistance of the FV sensor is above 5,000 ohms and lower than 1,700,000 ohms and all the above steps have been performed - ensure the wiring and plug between the sensor and the Intelli-Vent™ control are not damaged or worn - replace the ignitor assembly if the wiring and/or plug are damaged/worn.</li> </ol> <p>If the wiring and plug are in good condition - replace the Intelli-Vent™ control valve</p>
